Visual Timber Pest Inspection and Report in Accordance with AS 4349.3-2010

Pre-Purchase Timber Pest Inspection AS 4349.3-2010

1 STRUCTURE NAME: Unit 3

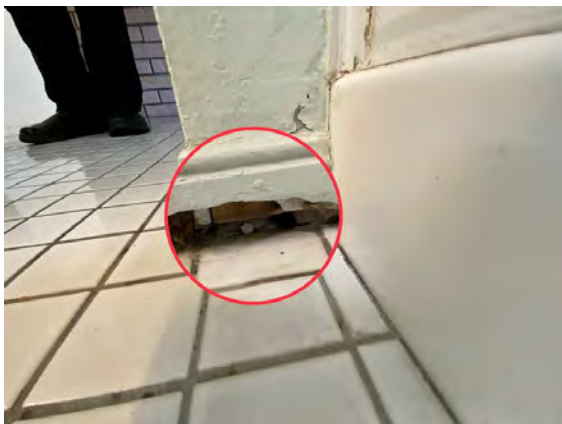
Moisture:	High
	High moisture levels conducive to timber pest attack
Termite:	No Termite Evidence Identified
Borer:	No Borer Identified
Fungal Decay:	Fungal Decay Identified
	WARNING: SEE NOTE ON FUNGAL DECAY
	Fungal Decay Visible
	Fungal Decay Damage Extent: Moderate
	Location of Threats Not Limited To: Skirting Boards
Is an invasive inspection recommended?	No
Are there Major Safety Hazards Related to Timber Pests?	No
	Important Note: Where a Major Safety Hazard is identified above, it <u>must</u> be attended to and rectified to avoid the possibility of personal injury &/or death.

Fungal decay to timber skirting at shower

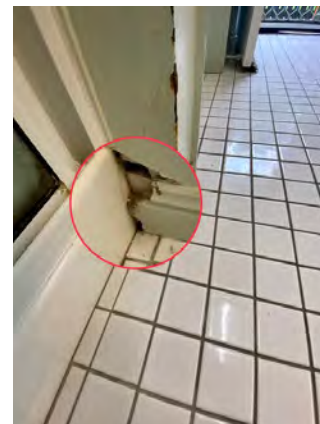
Fungal decay to timber skirting at shower

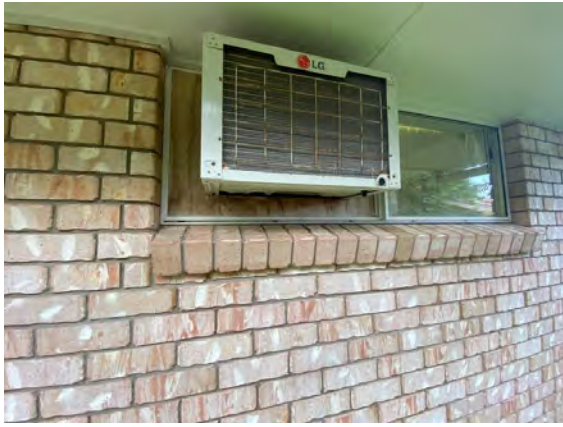
Air con overflow not connected to drain

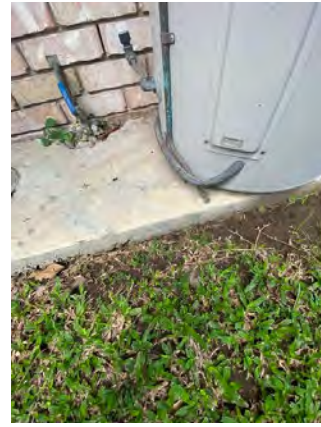
Hot water system overflow not connected to drain

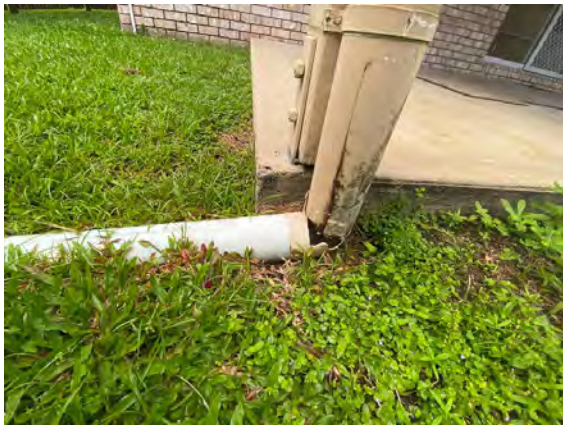
Downpipe leaking

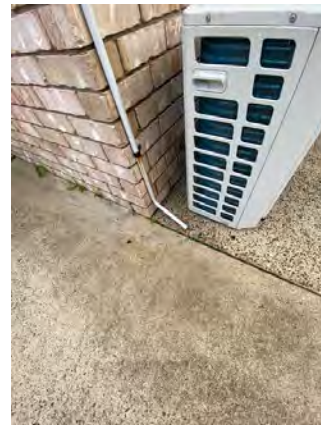
Air con overflow not connected to drain

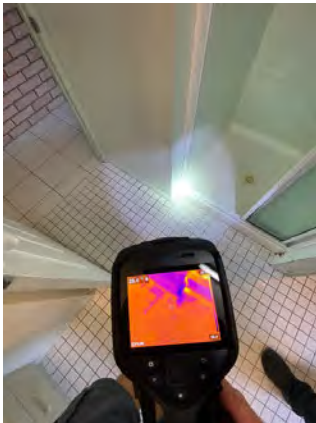
Apparent leak from shower tray when in use

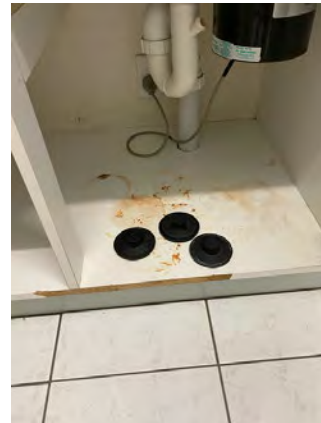
Some apparent water damage under kitchen sink- appears previous

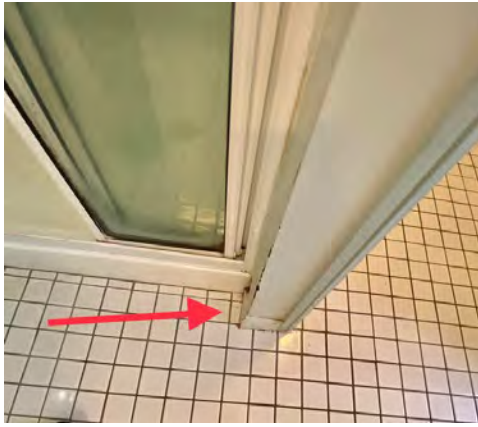
Apparent leak from shower tray when in use

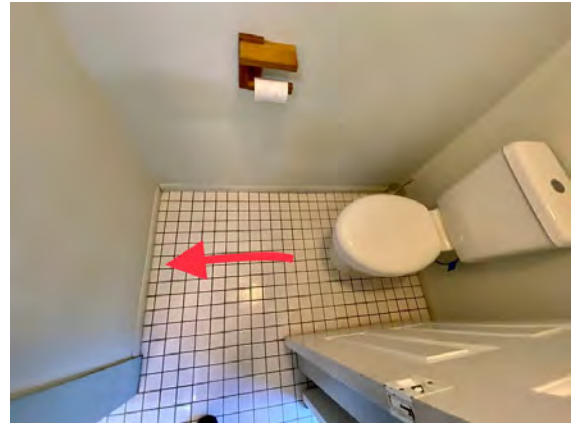
High moisture reading to toilet wall (adjacent to shower)

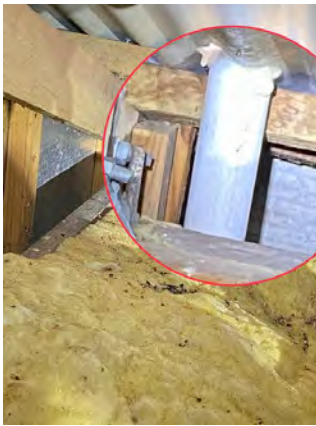
Some water stains to timber around vent pipe (bedroom 1) appears previous

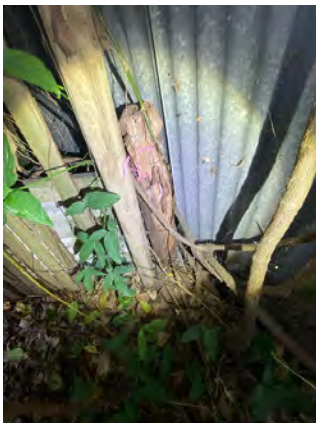
Termite: Yes
Termite Damage Visible
Termite Damage Extent - Moderate to Extensive

Termite damage to timber fence post - back yard

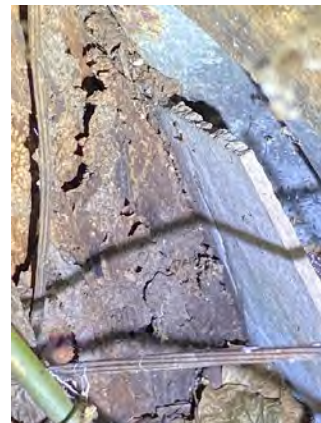
Termite damage to timber fence post- back yard

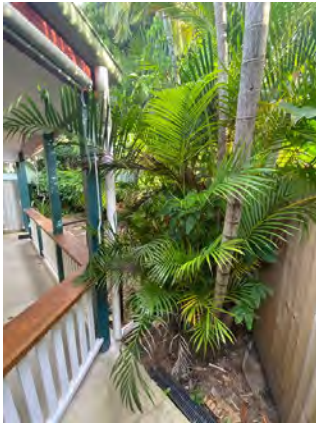
Trees/Vegetation in contact with structure, mulched gardens present

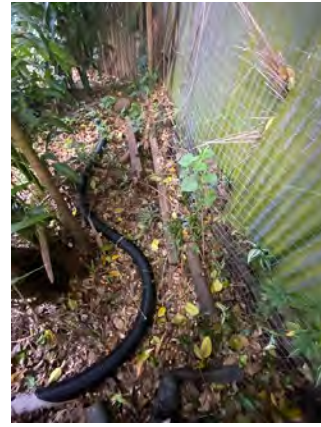
Timber on ground, mulched gardens, timber fencing in contact with soil

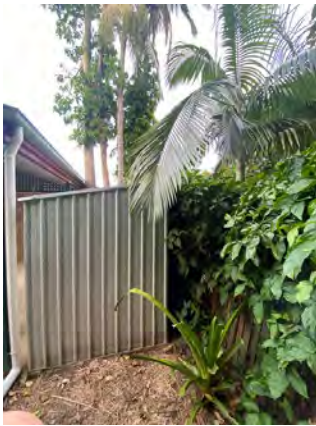
Vegetation against structures

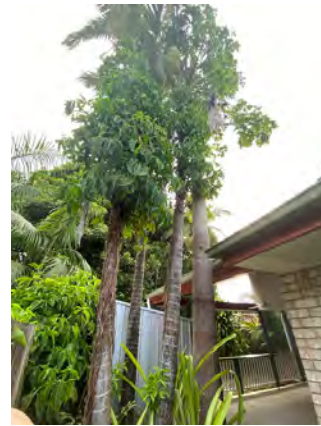
Large susceptible trees close to structure

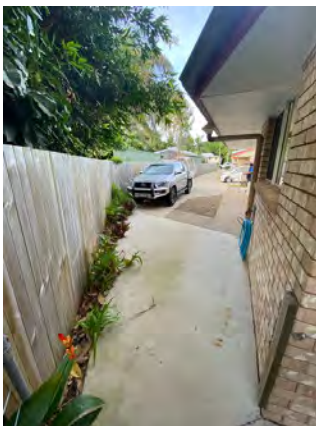
Mulched gardens close to structure

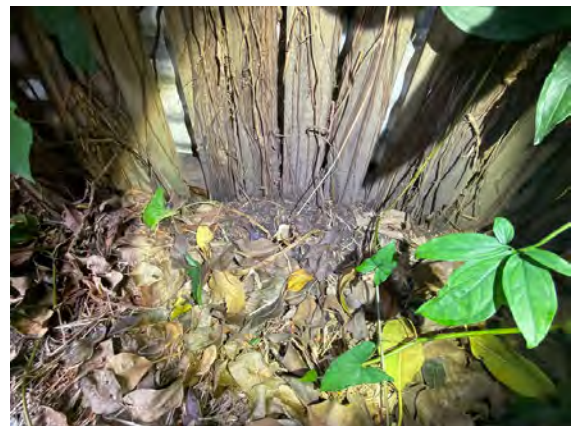
Mulched areas, timber fencing in contact with soil

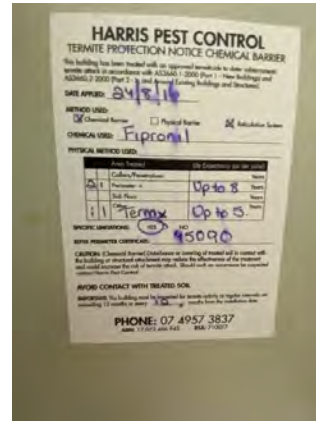
Image of Termite Management Sticker

Drill Holes - External, Reticulation System
Termix reticulated termite management system installed under slab at rear patio 24/8/16 expired 24/8/21
Termidor barrier installed to other areas of perimeter 24/8/16 with life expectancy of up to 8 years

Termite Management Recommendation: Recommended as the installed termite management system is not current
